Why everything gets broken or material scientific consideration of damages

Thomas Gietzelt / IMVT-MAT

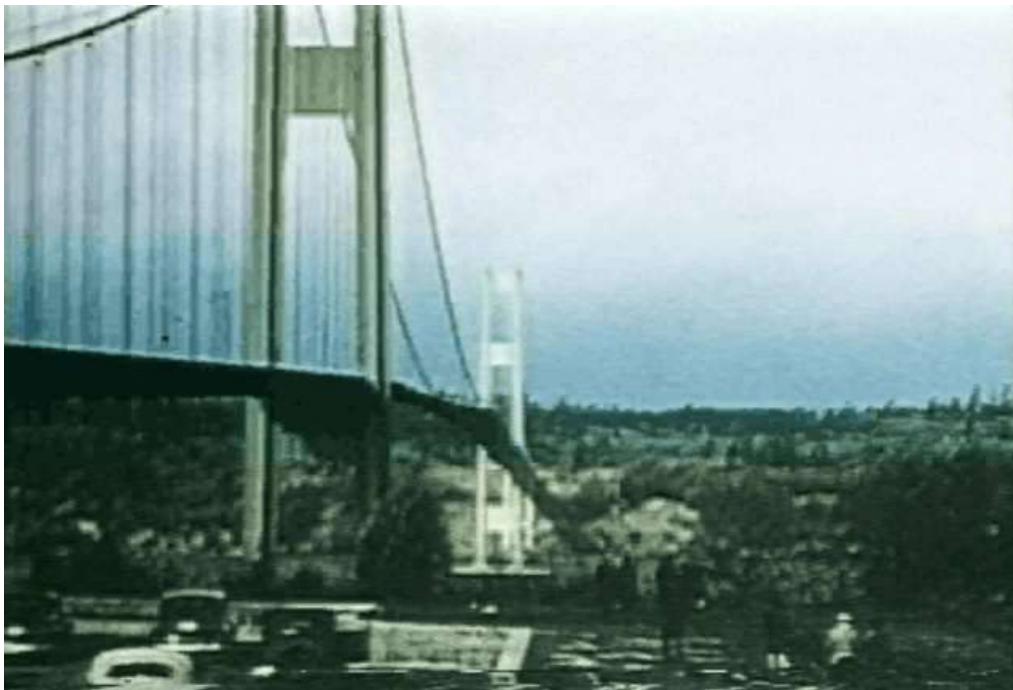
Design-Issues: Collapse of the Tacoma-Narrows-Bridge 07.11.1940

Reasons:

- Terrain profile (coast line formed nozzle)
- Rigidity of the bridge box too low, wrong self frequency calculation (resonance)
- It is impressive, what materials resist before failure...

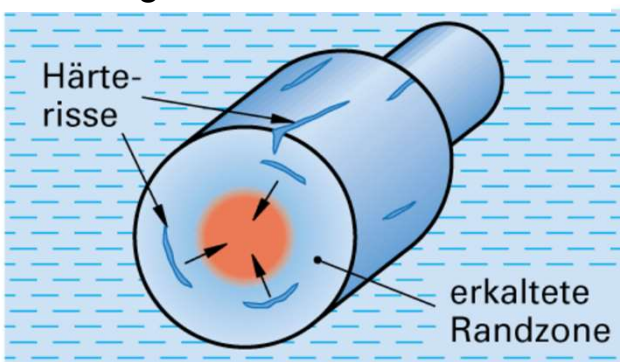
2nd phase: rigid shell impedes shrinkage of core

Hardening cracks due to volume change of austenite (fcc) and martensite (tetragonally distorted bcc), superimposition with thermal shrinkage

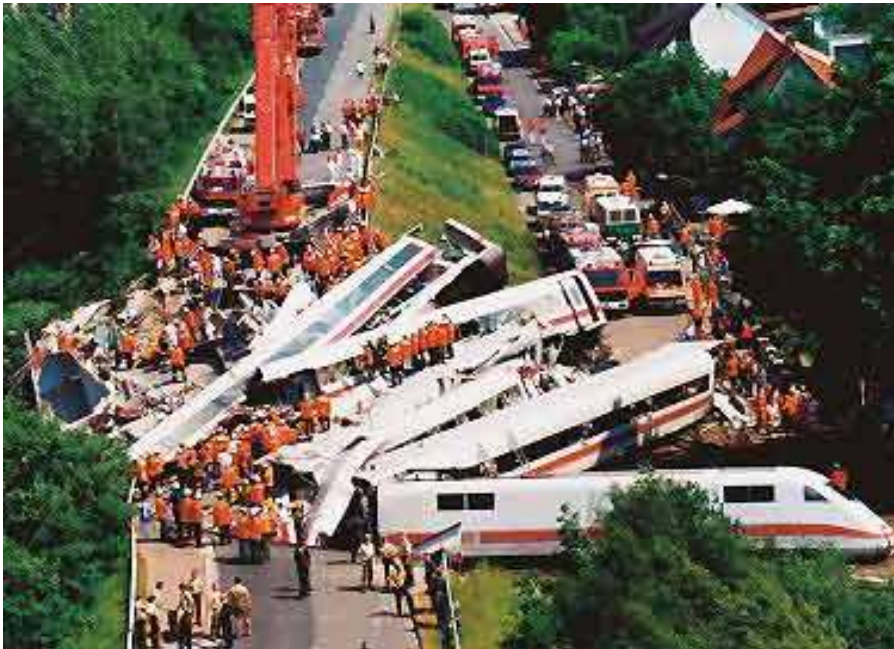
ICE-Disaster Eschede 03.06.1998 - A sequence of unfortunate events

- *Composite wheel: Fracture of wheel rim due to **material fatigue**.*
- *Wheel rim made of rolled and tempered carbon steel, joined to the wheel disc via rubber sleeve.*

- *At the wheel contact point, the wheel rim is bent inward => tensile bending stresses in the circumferential direction at inner side.*
- *Per revolution: **change of stress tension** ⇔ **compression**.*

- ***Amplitude increased by wear and runout.***
- *Fatigue failure after 1.8×10^6 km (**$6,2 \times 10^8$ load cycles**).*
- *Broken wheel wedged into the wheel control arm. Fracture pushed wheels out of rails.*

- *Intact wheel hits a switch that had just been passed and changes it. The following wagons derailed. A bridge pier is broken down. The collapsing bridge buries one wagon. The remaining wagons are pushed by the heavy rear powerhead.*

- *101 dead , more than 100 people injured.*
- ***Runout was noticed at last maintenance but considered still uncritical => crack growth faster than expected.***

- ***Consequence:** Reduction of maintenance intervals of wheelsets from 300,000 => 60,000 => 30,000 km (capacity problem for maintenance)*

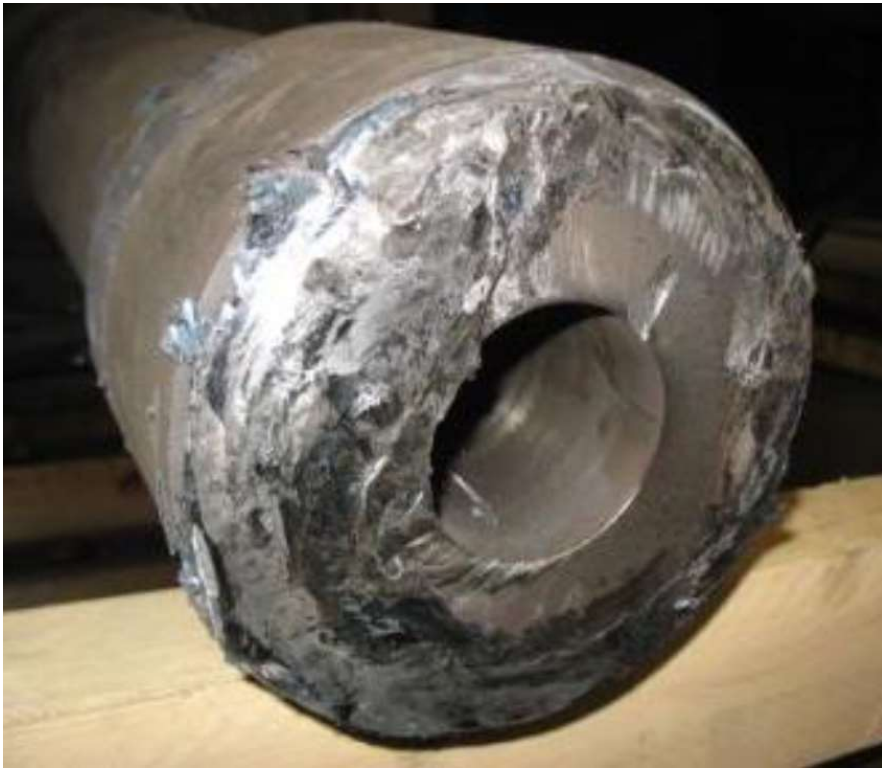
Wheelset shaft fracture at ICE 3 on 09.07.2008 in Köln

Broken axle shortly before Cologne main station; train derails on departure (!)

Reason: Manufacturing-related material inclusions in the wheelset shaft.

Only fortunate circumstances prevent an accident; cruising speed shortly before 330km/h!

Consequence: Reduction of maintenance intervals of wheelsets from 300,000 => 60,000 => 30,000 km (capacity problem for maintenance)

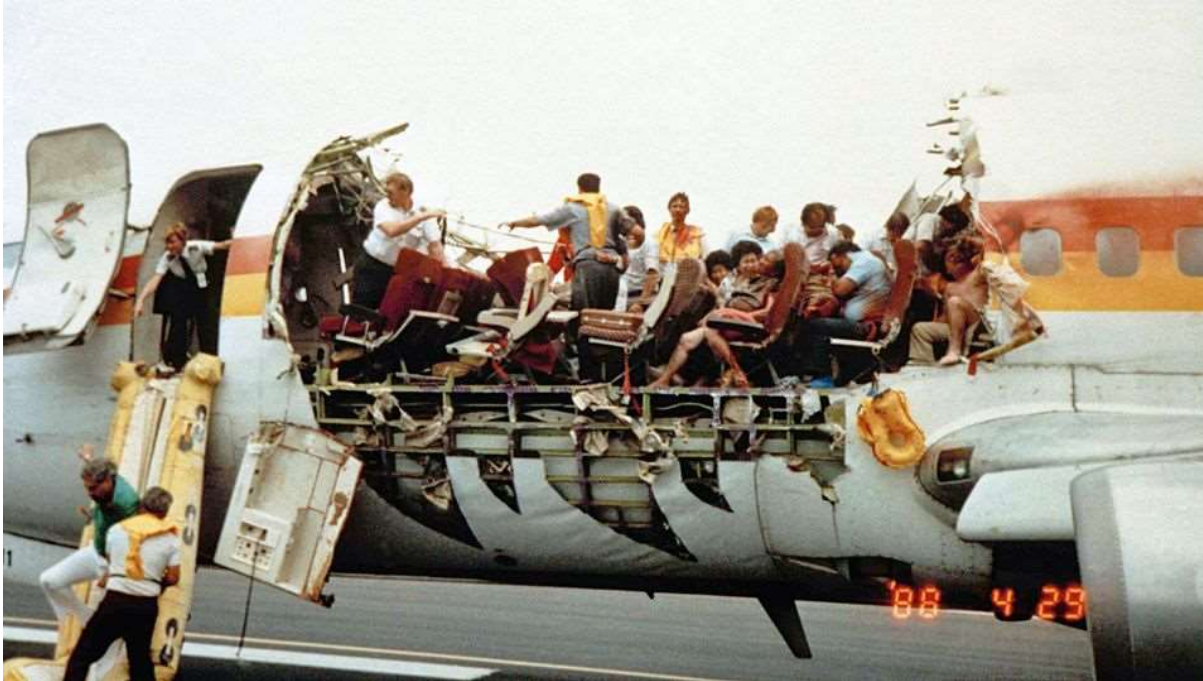
Aloha-Airlines-Flight 243, (Boeing 737-200, 28.4.88)

- Island-hopping (short range)
- after 90.000 cycles (designed for 50.000 only *)
- corrosion (salt spraying) +
- fatigue (Δp)
- Crack propagation between rivet holes in the hull @ 7300 m

- 1 flight attendant sucked off (†)
- 65 people injured, 7 of it severe

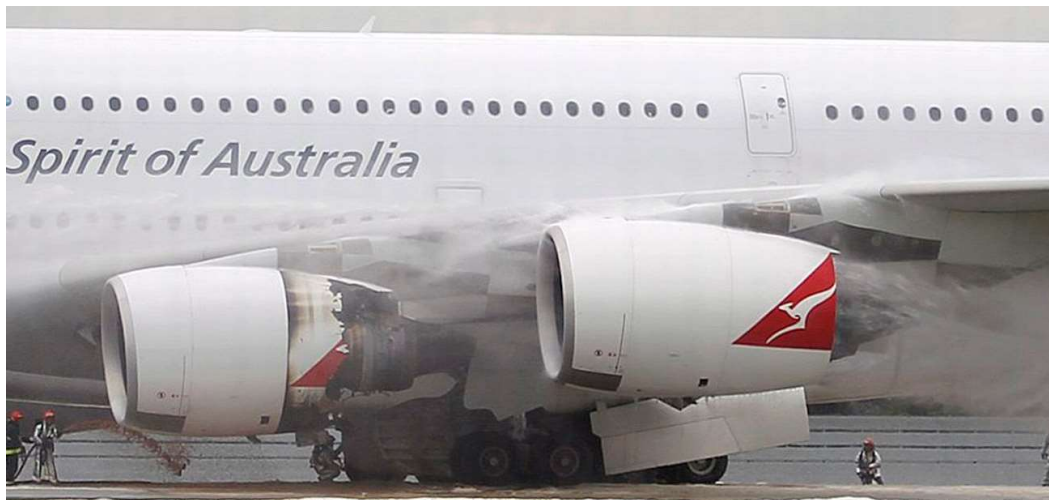
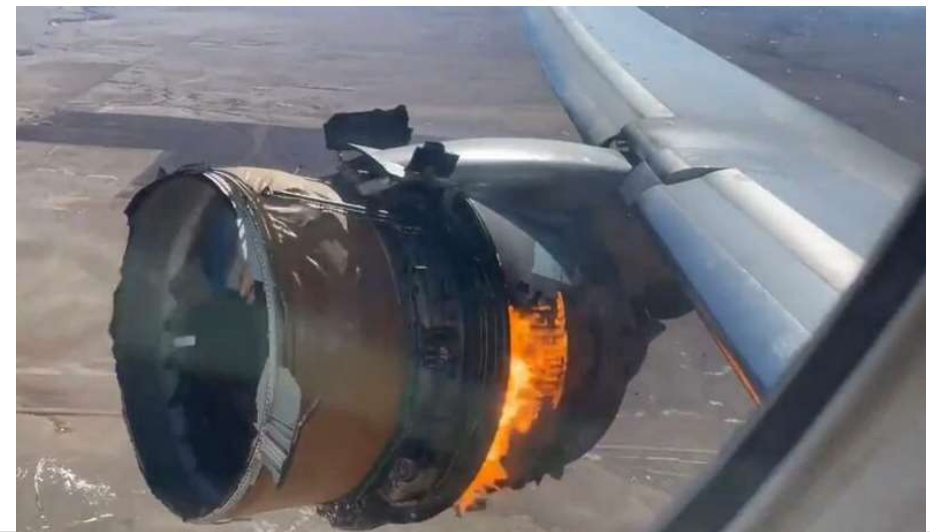
Flight QF32 (A 380, 4.11.10) and United-Flight UA328 (Boeing 777, 20.2.21 and some more....)

- Fatigue fracture of an oil rail in the RR Trent-900 engine
- Turbine disk detached from drive shaft due to oil fire.
- Engine casing, left wing, 2 tanks & hydraulic lines penetrated.

- two fan blades broken

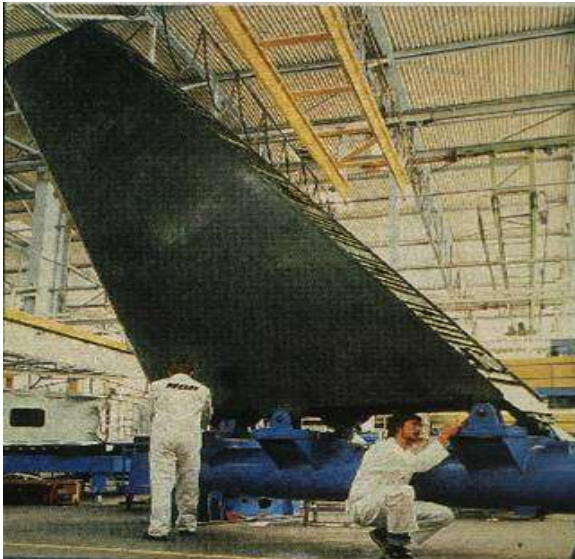
Composite Materials: Crash of AA 587 (Airbus A300, 4.11.01)

- Generally: Problems with NDT, no ultrasonic testing possible.
- Airbus A300 flew through wake vortices of a previously launched Boeing 747 after takeoff in N. Y.
- Copilot reacted with full deflections of the rudder in both directions (hydraulically operated, no haptic feedback!).
- Load limits were exceeded, rudder broken.
